# Manhole Inspection Summary

Manhole # S29YY1003MH

**Location** Address: **5200 AMBERLY WAY**

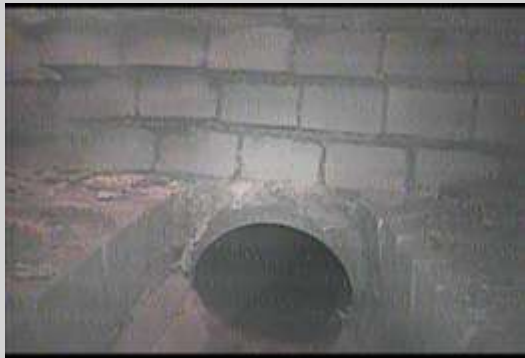
### 8 in. Circular Gravity Sewer Pipe Out @ 12 O'Clock

Rod and Bar (Angled)

Pipe Material: **Clay** ☐ Pipe Lined

Infiltration: **None** Pipe Seal Cond: **Unknown**
